# Leading Edge erosion and pollution from wind turbine blades

5 th. Edition - English

Asbjørn Solberg, Bård-Einar Rimereit and  
Jan Erik Weinbach  
"THE TURBINE GROUP" JULY 2021

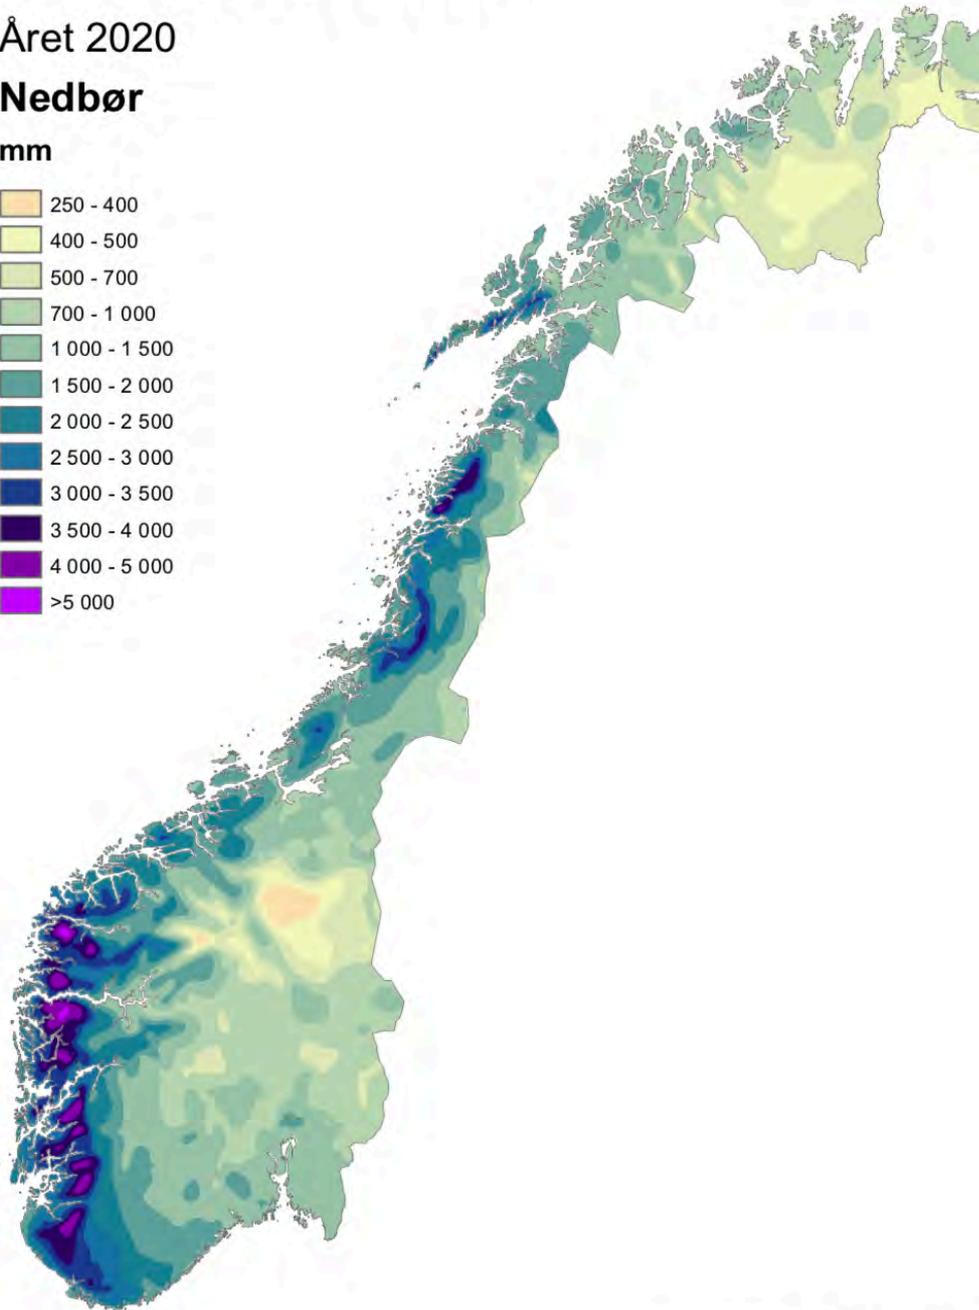
#### Nedbør

Normalperioden er 1961 - 1990

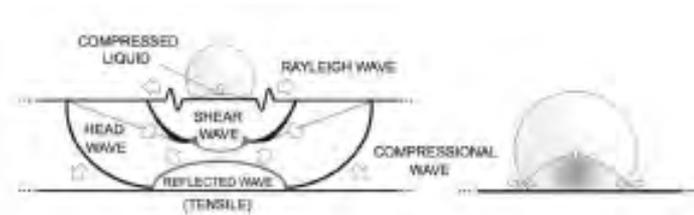
Some reports say the coating is polyurethane while "*On the Material, Characterization of wind turbine-B\_2017*" says that the cover layer on the Leading edge is also a specially developed epoxy "*developed for Leading Edge Protection*" (LEP)<sup>10</sup>. The same report also explains the mechanisms surrounding damage caused by raindrops, defined as the Water Hammer pressure effect.

Figure 1 source: *On the Material, Characterisation of wind turbine-B\_2017*

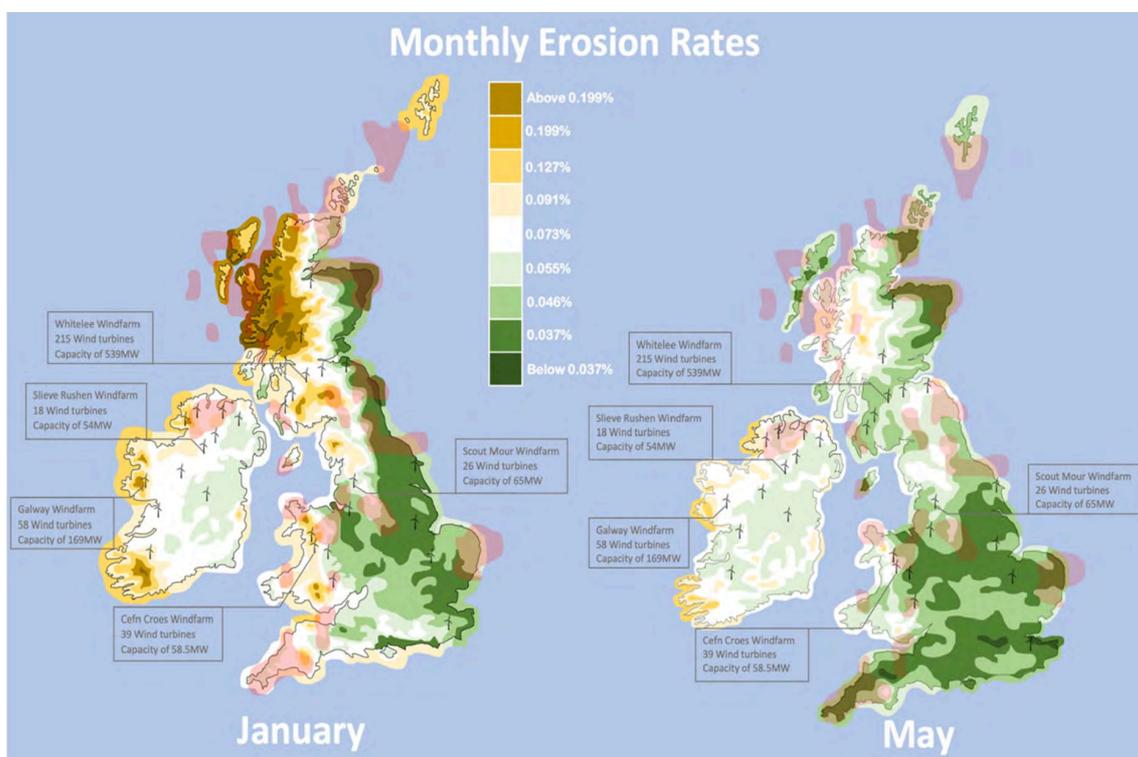
Figure 1. The monthly erosion rates in January and May with overlays of major wind turbine farms and areas of frequent hail. Source: Journal of Bio- and Tribo-Corrosion · March 2021)

The mass of the test material was measured before the experiment and after each exposure time. This will result in a direct numerical relationship between average monthly rainfall and erosion as a mass loss.

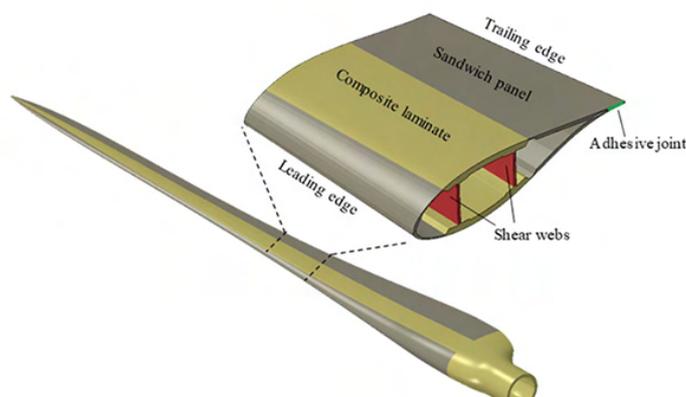
Figure 3 Typical wing profile

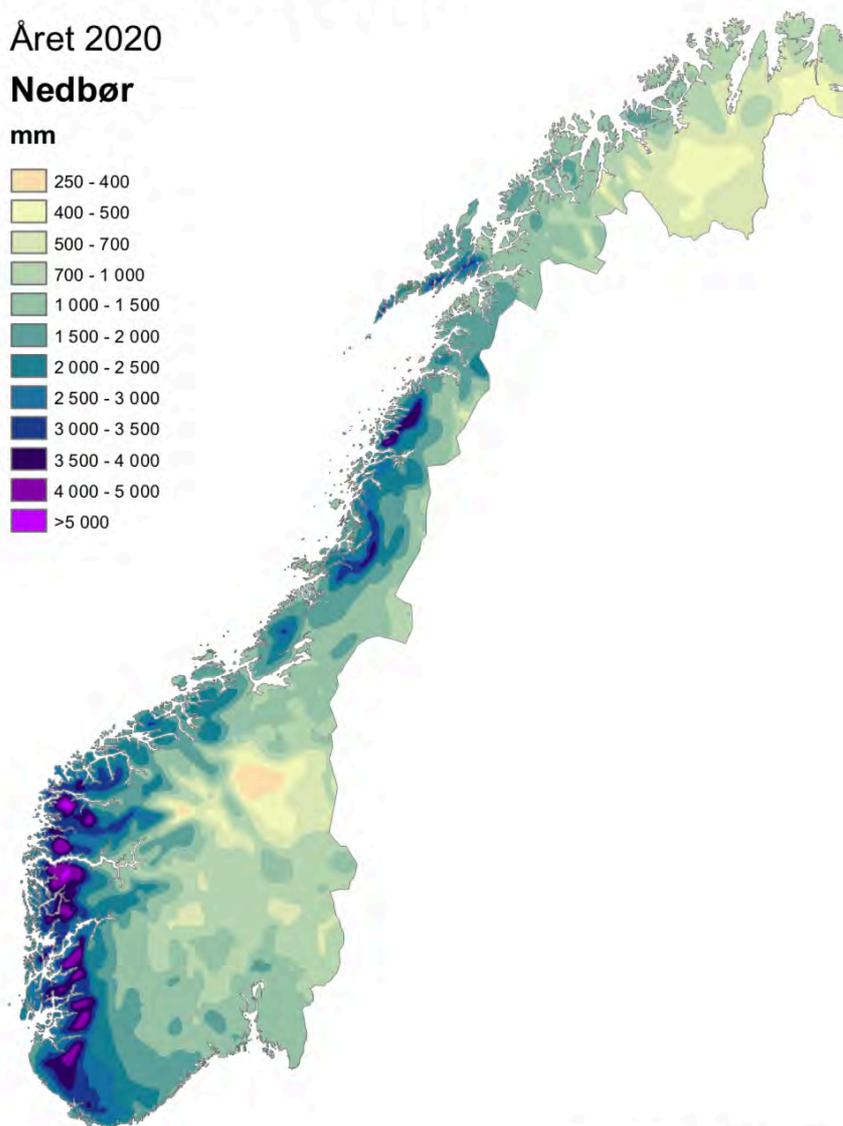
**Nedbør**

Normalperioden er 1961 - 1990

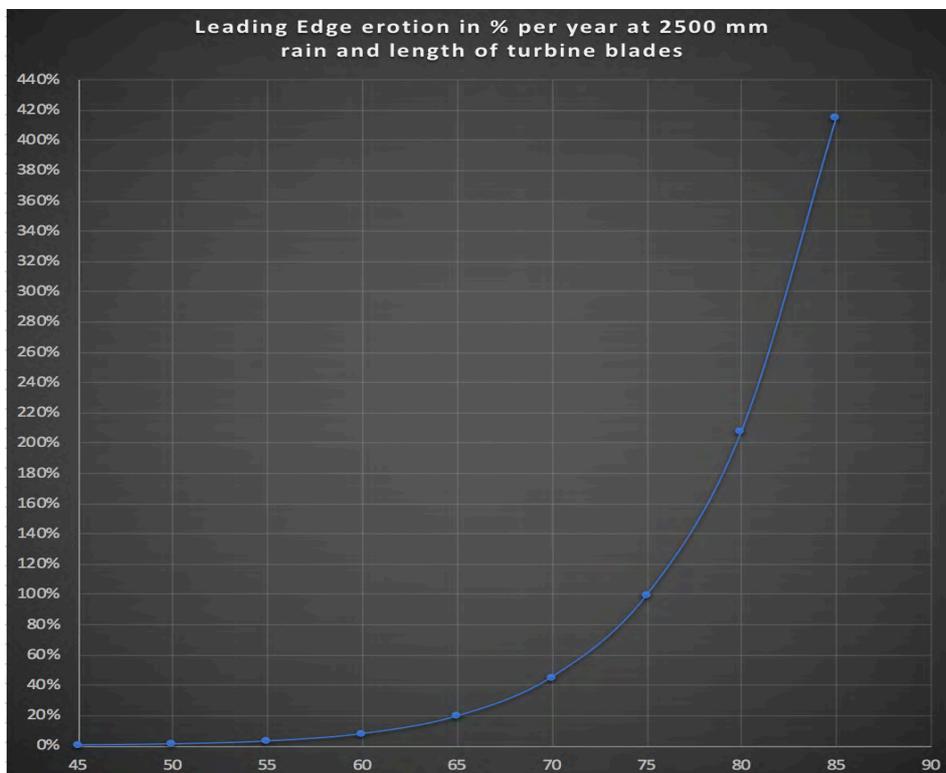
**Erosion Rate is exponential to Impact Speed or Impact Energy (see graph)**

Figure 4. erosion (loss in percent) as a function of precipitation, speed and length of turbine blades

**Erosion Rate is exponential to Impact Speed or Impact Energy (see figure 4).**

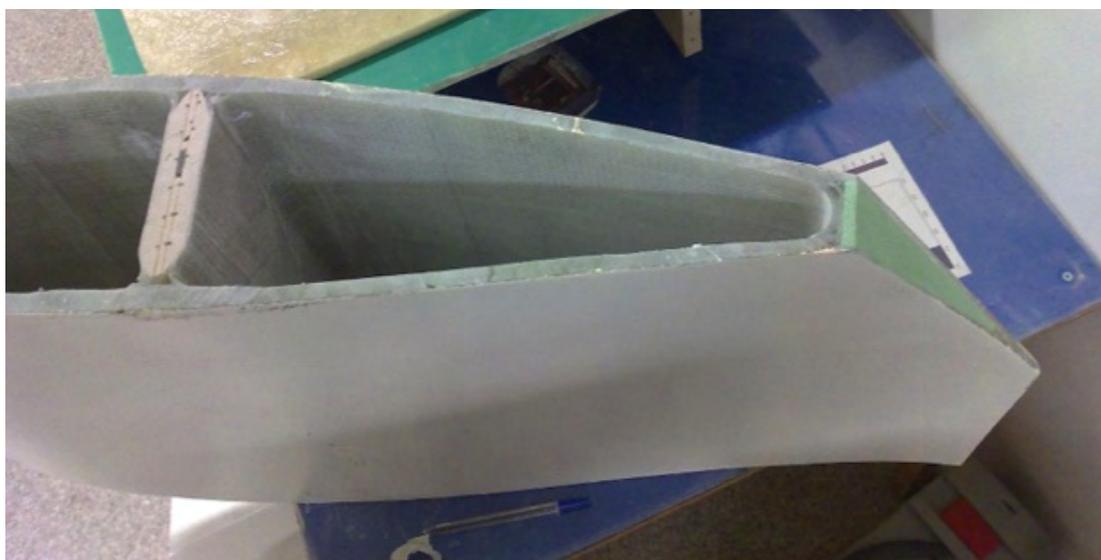
Figure 5 Photo: A small blade profile - to get an impression of proportions. Own photo, from testing

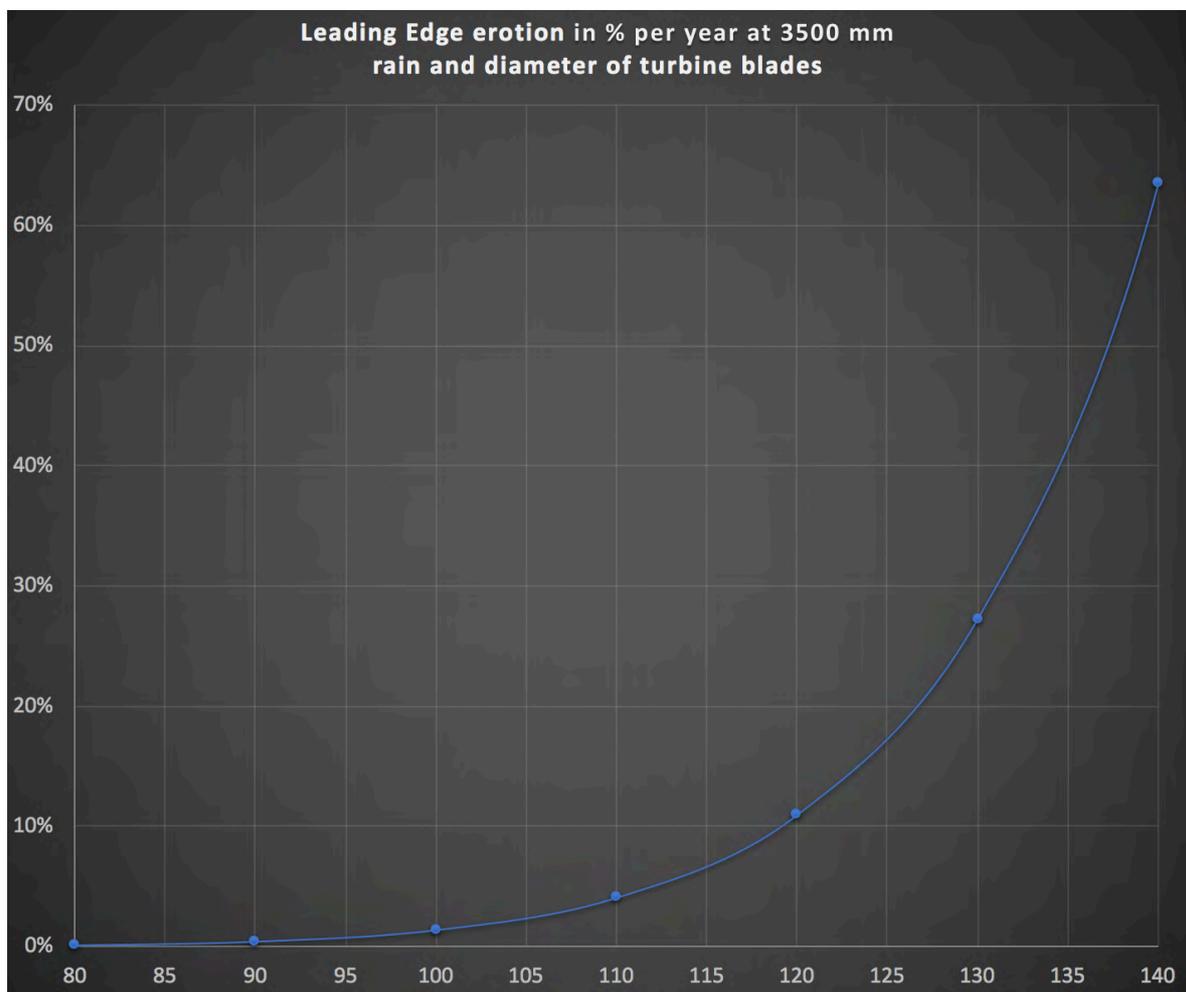
Figure 6. erosion (loss in percent) as a function of precipitation, speed and length of turbine wing

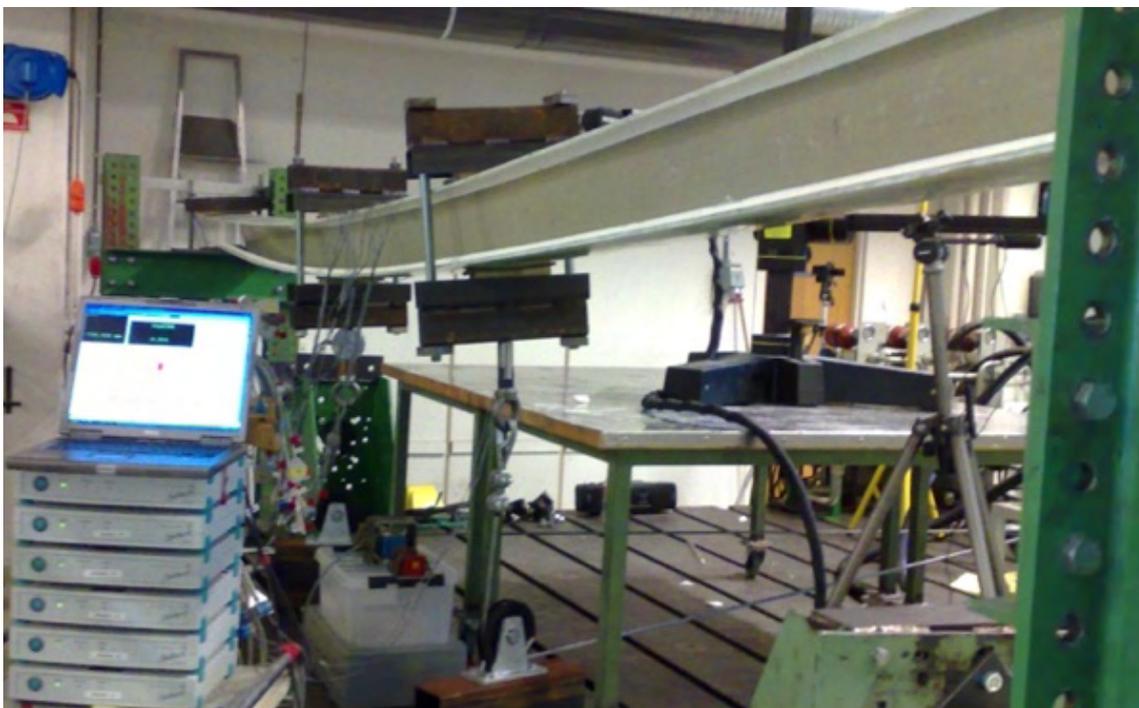
Figure 7 Photo: Bending test of a section on a wing profile. Own photo, from testing
